AIRCRAFT GROUND-FLOTATION INVESTIGATION

PART III. DATA REPORT ON TEST SECTION 2

TECHNICAL REPORT AFFDL-TR-66-43, PART III

APRIL 1966

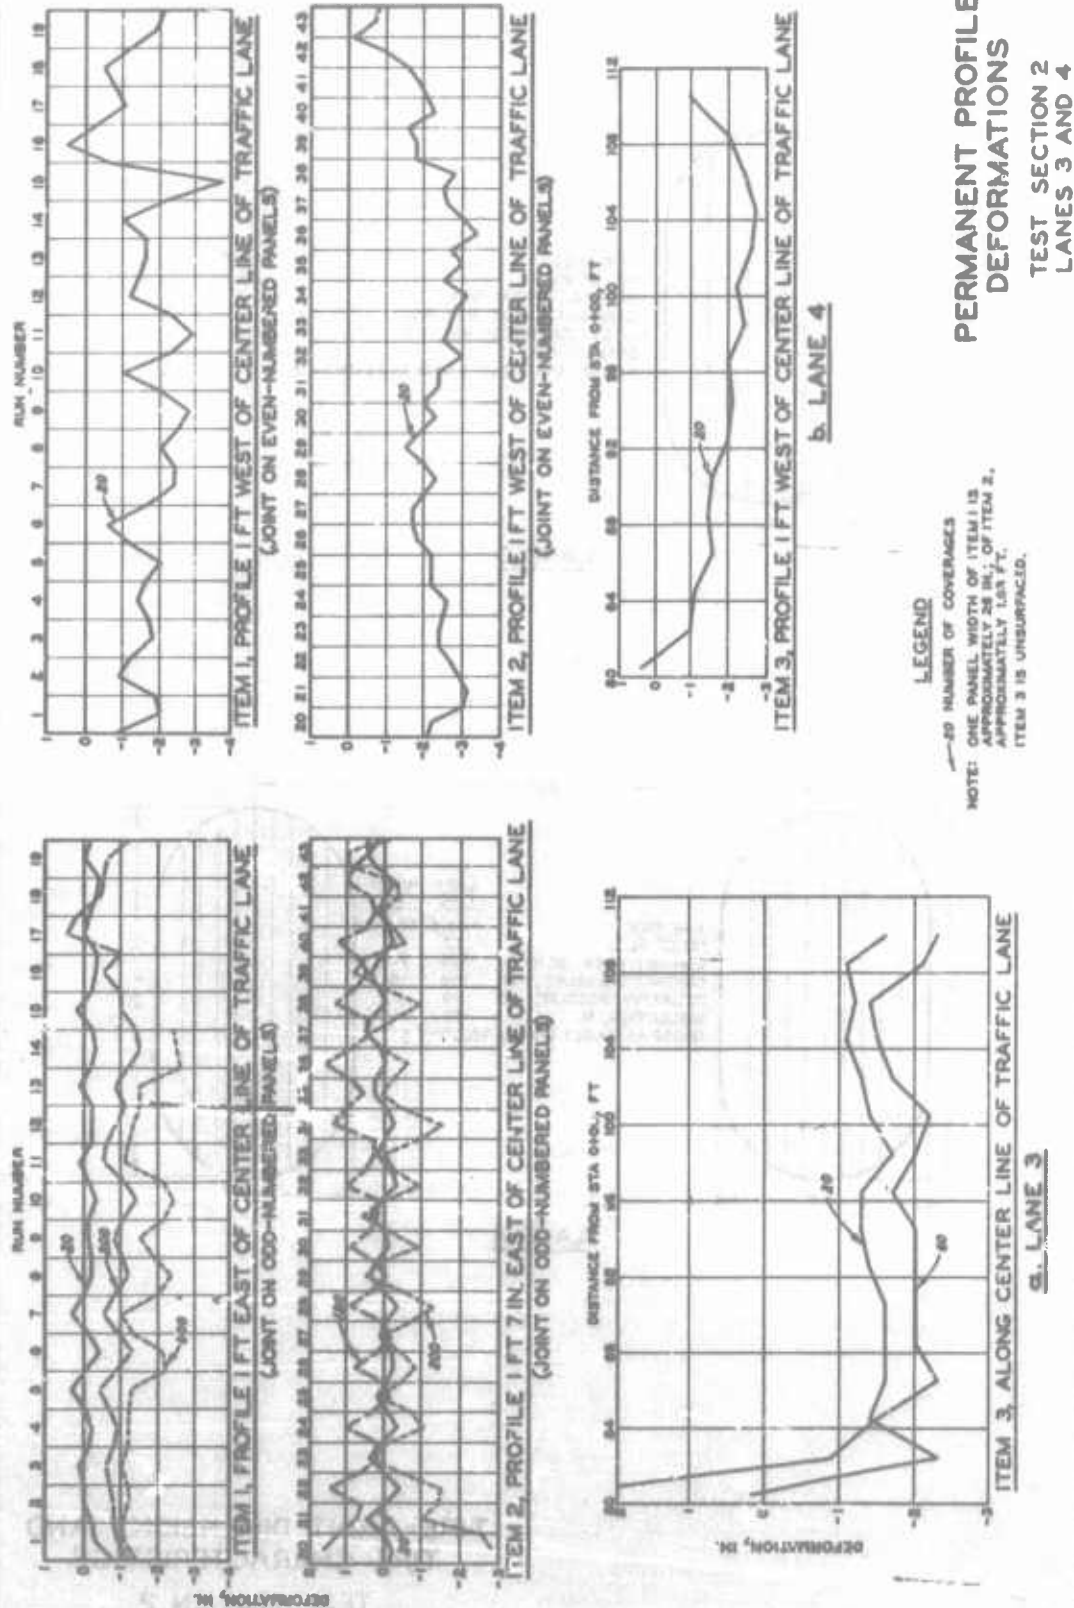
Figure 29

- b. Deformation. Average profile and cross-section deformations are shown in Figs 29 and 30, respectively. The maximum deformations occurred along the joint line 1 ft west of the center line. Fig 30 shows a maximum cross-section deformation of 1.9 in. for the item. The profile plots in Fig 29 illustrate the severe deformation and roughness that occurred along the direction of traffic.

b. Deformation. Average profile and cross-section deformations are shown in Figures 29 & 30, respectively. Maximum deformation occurred along a line near the end joints on the west side of the lane.

b. Deformation. Average cross-section deformations are plotted in Fig 30 for the 20-coverage level. Significant changes in the cross section occurred with each pass of the load vehicle due to severe rutting beneath the load wheels. The profile plot in Fig 29 indicates a general subsidence along the longitudinal direction of the traffic lane.
